**DEPARTMENT OF TRANSPORTATION**

Contract #: 04-0120F4Cty: SF/ALA Rte: 80 PM: 13.2/13.9File #: 1.28**WELDING INSPECTION REPORT****Resident Engineer:** Casey, William**Address:** 333 Burma Road**City:** Oakland, CA 94607**Report No:** WIR-029840**Date Inspected:** 19-Jul-2013**Project Name:** SAS Superstructure**OSM Arrival Time:** 700**Prime Contractor:** American Bridge/Fluor Enterprises, a JV**OSM Departure Time:** 1730**Contractor:** American Bridge/Fluor Enterprises, a JV**Location:** Job Site

**Tower Electroslag Welds:**

Electroslag Weld Repairs at Ring Beam Layout Locations

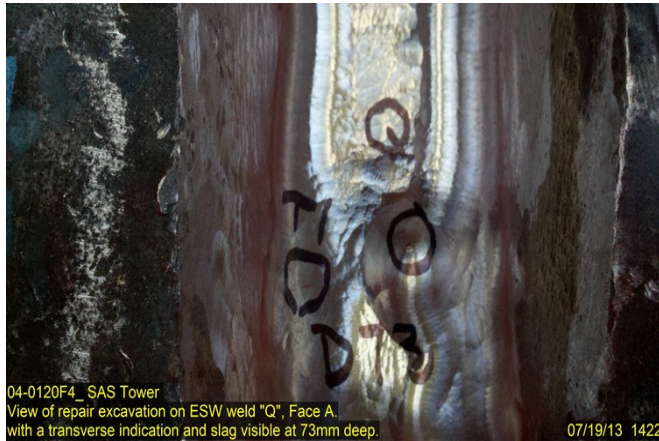
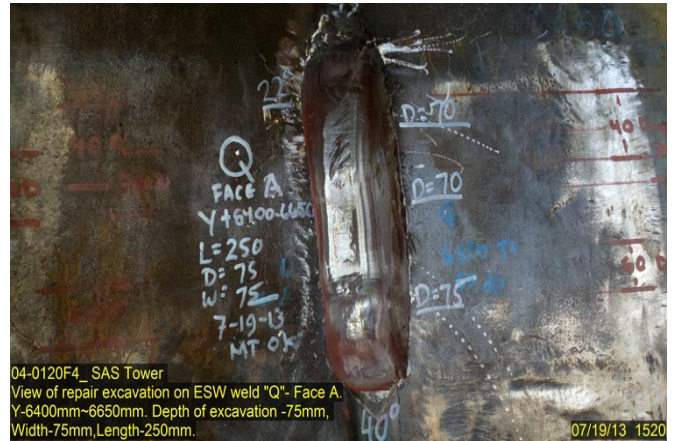
The QA Inspector observed at random intervals, ABF/JV welder Don Plumb (WID-0891) performing carbon arc air gouging of ESW "Q" Face A, to verify indications observed during Ultrasonic Testing. ABF Quality Control (QC) Inspector Bernie Docena was observed monitoring the work and informed the QA Inspector that all indications in these Y locations will be removed and repaired for ring beam installation. Locations of the repair excavation and indications observed are as follows:

ESW Q -Face A

Y= (Original) 6460mm, 6470mm, 6560mm. Excavated 6400~6650.

Transverse indications were observed at depths of 50, 55, 60, 65,70,73mm.

Slag type indications were observed at depths of 50, 55, 60, 65, 70,73mm,

No indications observed in final excavation of 75mm deep.

L= 250mm, W= 75mm, D= 75mm\*

During excavation and after grinding to bright metal Mr. Docena was observed performing MT testing at various intervals of the excavation to ensure the discontinuities were removed. The QA Inspector also performed MT inspection of the excavation and did not observe any weld defects. ABF QC Inspector Bernie Docena stated that the weld excavation has exceeded the maximum allowable depth of excavation (\*85% of weld thickness) for the 80mm to 100mm transition weld. Mr. Docena also stated that ABF QC Engineers Eric Blue and Chris Chew were aware of the situation and will present to CT METS for approval prior to welding. See TL-6028 for information on
